TO THE T HOME INSPECTIONS LLC

Property Inspection Report# XXXXXX
Client: XXXXXX
Property Address: XXXXXXXX ST SW Edmonds WA 98026
Inspection Date: 9/30/11
WSDA ICN # 1239AQ014

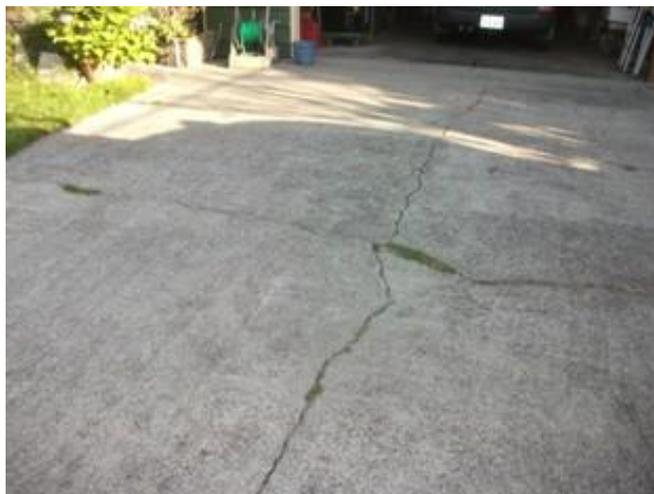
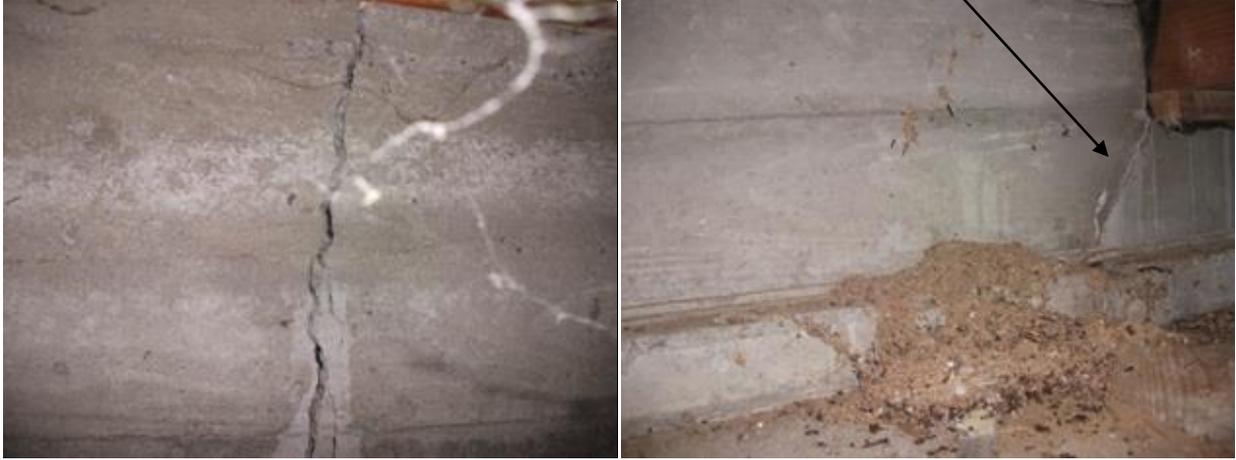
Evaluate: The driveway has cracked in many areas. This can be common in older houses. However when I was in the crawlspace there were two or more moderate cracks (1/8 inch to 3/4 inch) found in the foundation along the southeast corners. These may be a structural concern, or an indication that settlement is ongoing. You should consider hiring qualified contractors and/or engineers as necessary for further evaluation. Such contractors may include:

At a minimum, recommend sealing cracks to prevent water infiltration. Numerous products exist to seal such cracks including:

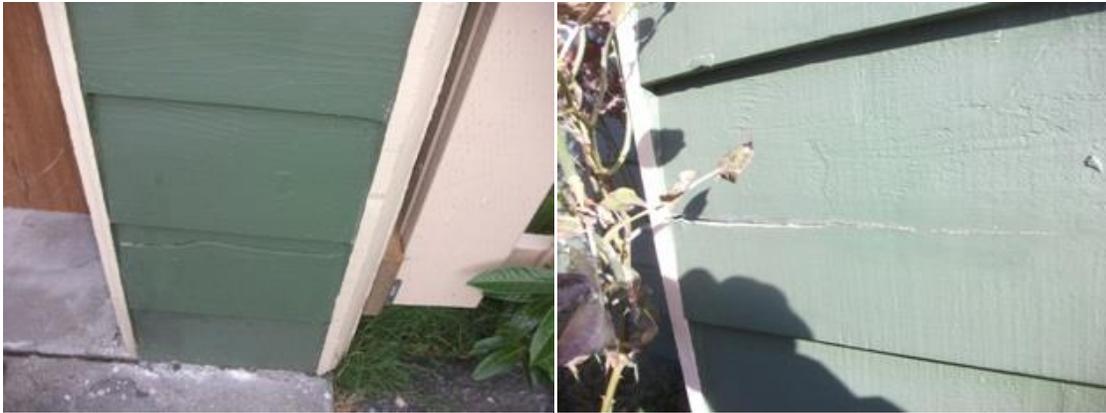
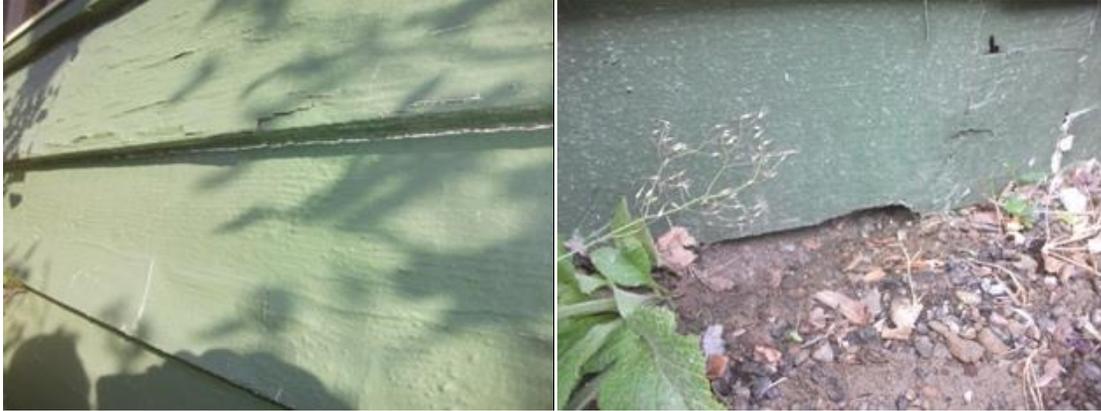
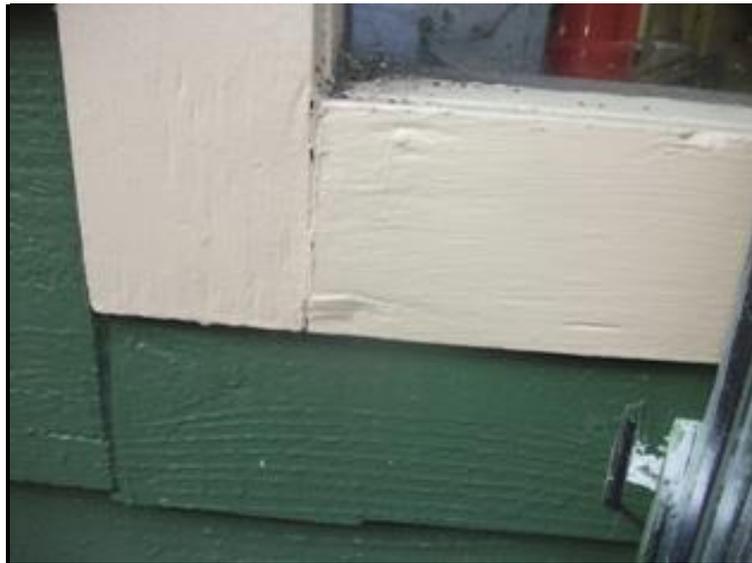
Repair/replace: There are many areas around the house where siding and trim needs to be repaired. Siding pieces on both sides of the garage are damaged and need to be replaced. On the northwest side of the house, on the deck at foot level a piece of siding has decayed and needs to be replaced. On the east side of the house, window trim has decayed. Below the gas meter on the east side some siding has also decayed. All of these decayed materials need to be removed and replaced. I also recommend a qualified painter re-caulk all areas needed, scrape all chipped paint and re-paint the entire exterior.

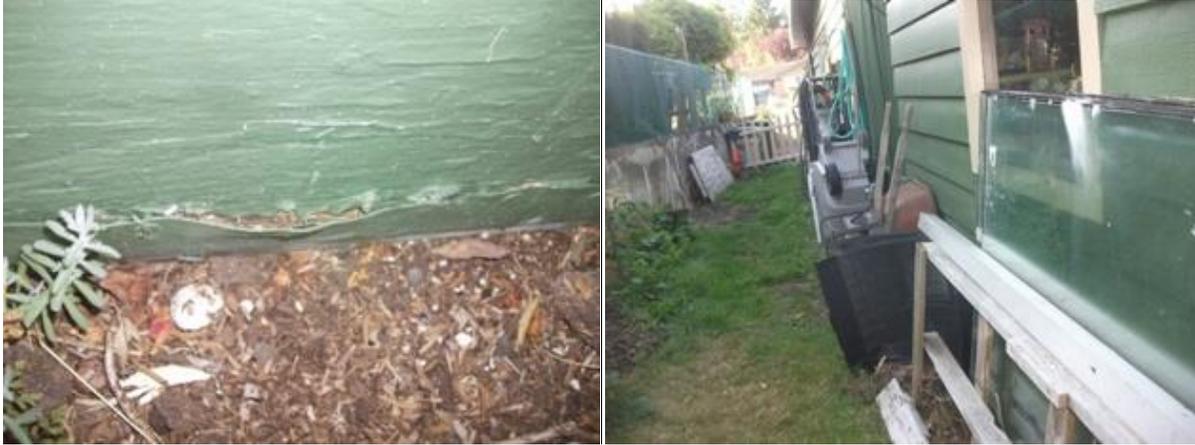
Repair/evaluate: Soil is contacting the siding in many areas around the south and east side of the house. I was unable to evaluate the east side due to stored items. On the front of the house I could not evaluate the siding because there is a metal skirt board against the siding with soil pushed against that. This is an improper application. The metal skirting should be removed so the siding can be inspected and all soil needs to be lowered 3”6” below the bottom row of siding. When these items area removed someone qualified need to evaluate the siding materials. Noted below in the **crawlspace section**, in the same location where metal skirting is on the front of the house there is a large mound of carpenter ant frass in the crawlspace. In my professional opinion, there is a definite correlation which needs to be corrected.

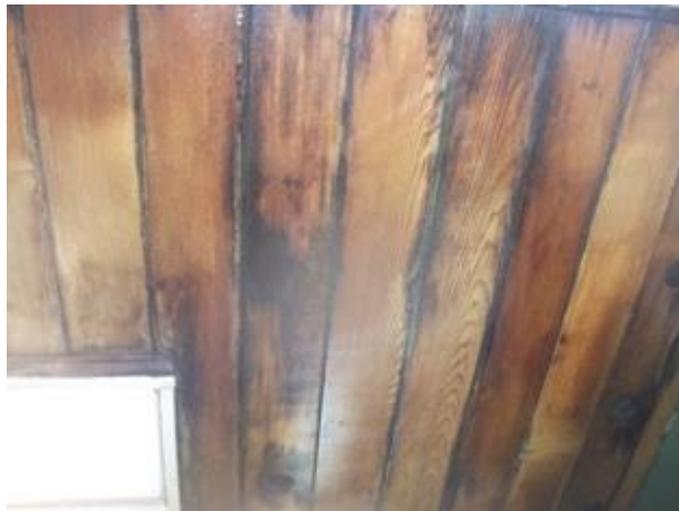
Evaluate: The soffits around the perimeter have mildew stains on them. This is common in our area. I inspected many areas with my pick and there did not appear to be any soft spots leading to fungal decay at the time of the inspection. You have a built-in gutter system which commonly fail and leak into the soffit area. I would monitor the soffits for additional or growing water stains. If staining continues to grow they need to be further investigated by someone qualified.

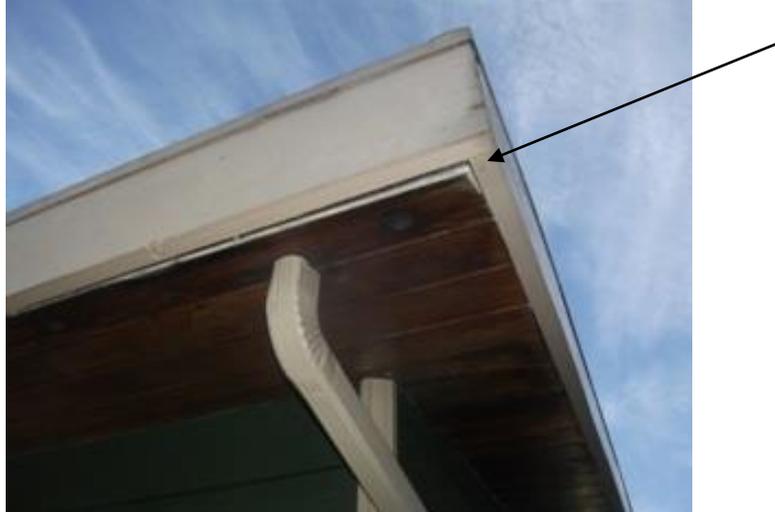
Repair: The southeast soffit has come loose. I could slightly see inside and there were two wasp nests present. They did not appear to be active. I recommend re-fastening the soffit so no insects can enter and nest.

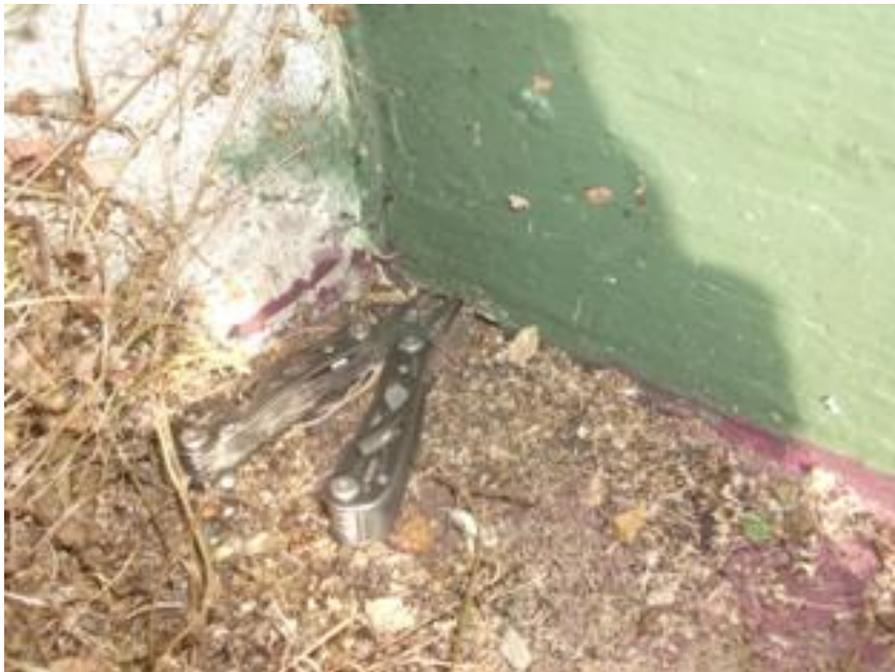
Repair: On the west side of the front door there is damaged and decayed siding. Vegetation is growing on the siding and concrete is poured against the siding. Both are conducive conditions for wood destroying organisms and insects. The front porch also does not have adequate slope away from the building. While I was evaluating the decayed siding, a carpenter ant emerged from the decayed material. I recommend contacting a licensed pest control specialist to evaluate, repair, and treat the area as necessary. **See crawlspace section for additional carpenter ant infestations.** A qualified contractor should evaluate the slope of the patio and repair the siding as necessary. All vegetation needs to be away from the building.

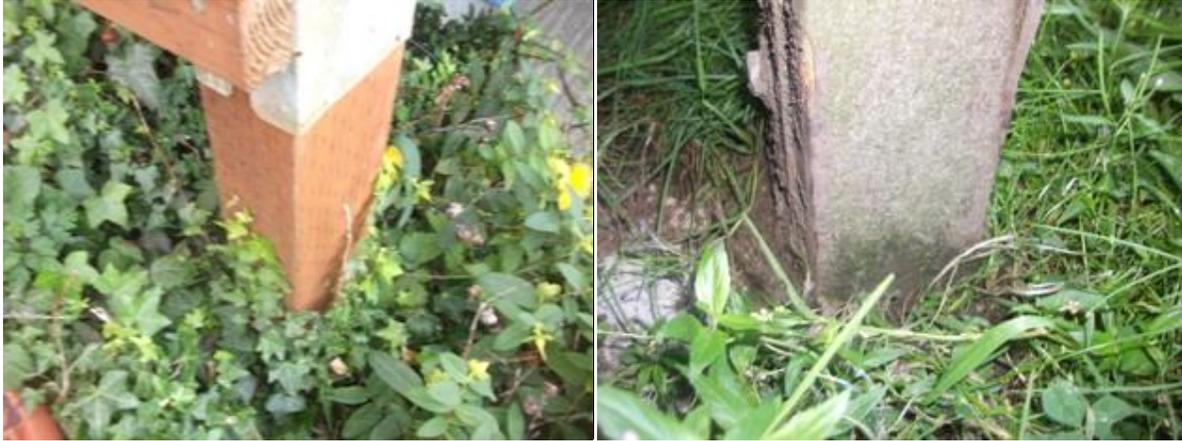
Maintain: The back deck posts need to be away from soil contact and vegetation. Even treated materials will decay over time.

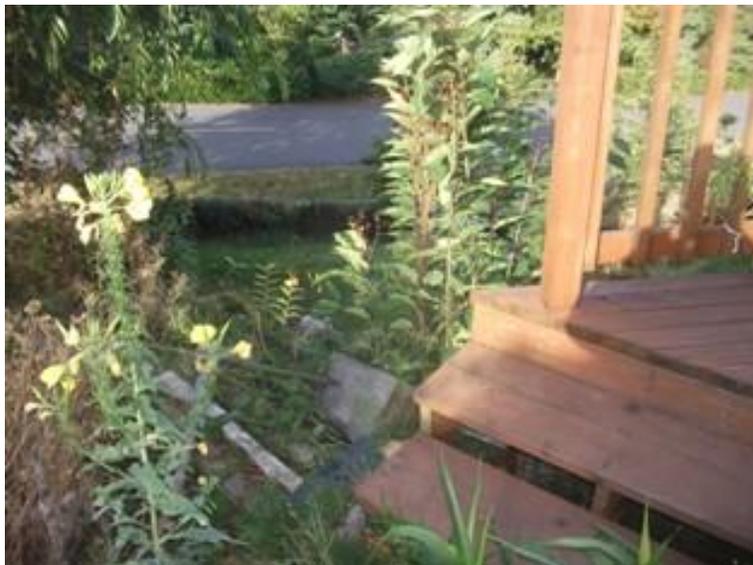
Safety: Safe building practices require handrails on stairs if there are 4 or more risers. On the west side of the house the stairs do not have a hand rail. There are only 3 risers so a handrail/guardrail may not be required. However, I recommend installing one as a safety feature for your daughter. On the other side of the stairs there is a pretty nasty fall which could really injure someone.

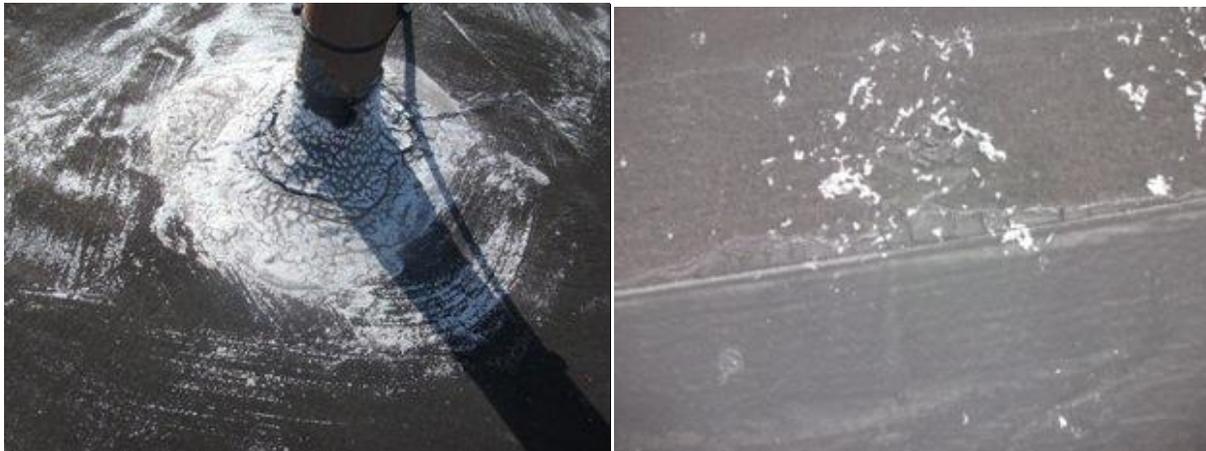
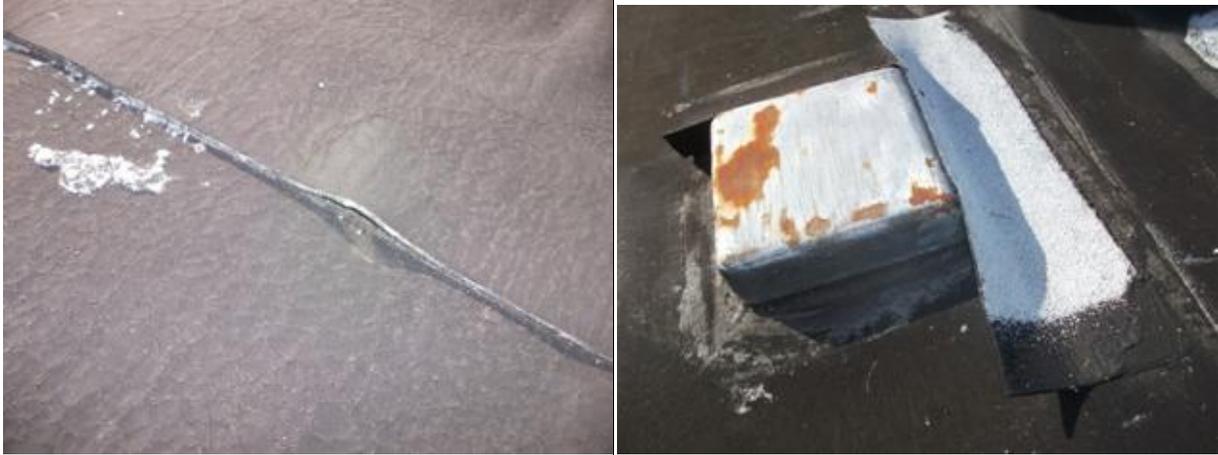
Evaluate/repair: The roof did not appear to be in good condition. Many areas have alligator type patterns, meaning the material cracks in cubical patters which look similar to alligator skin. Eventually these cracks open up and expose roof sheathing. Vents are poorly flashed, and many seams are loose. **In my opinion this roof needs to be replaced.** I could not access the attic to see any water stains or leaks. In the garage there is a lot of moisture staining on the exposed roof sheathing. That may also be from a humid and moist garage. I recommend a professional roofer who specializes and is licensed for torch down roofs to evaluate the roof and make the determination if the entire roof should be redone.

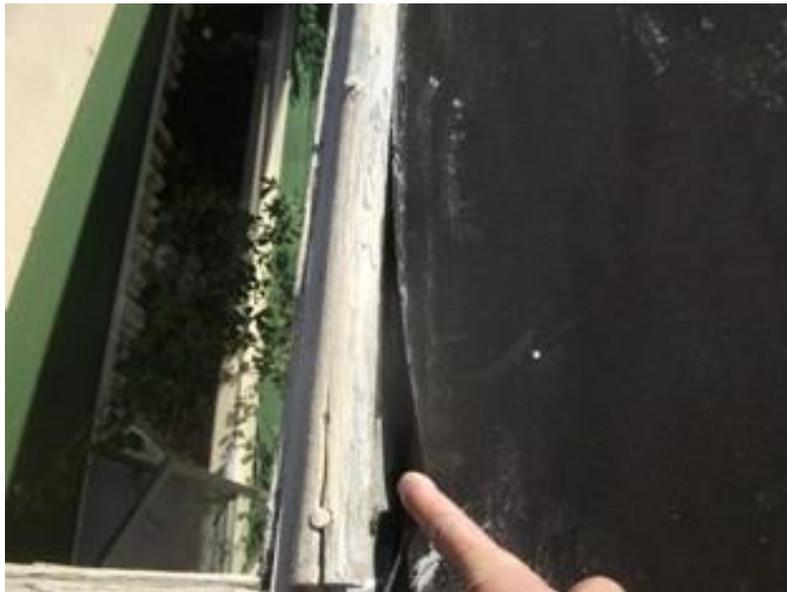
Repair: There is a skylight cut out above the entrance. The wood frame and cap have started to decay. On the walls of the frame there needs to be a counter flashing to lap over the roofing material. Currently there is none and the roof sheathing is exposed. I recommend someone qualified installs a cap to act as a counter flashing so water does not get under the roofing material.

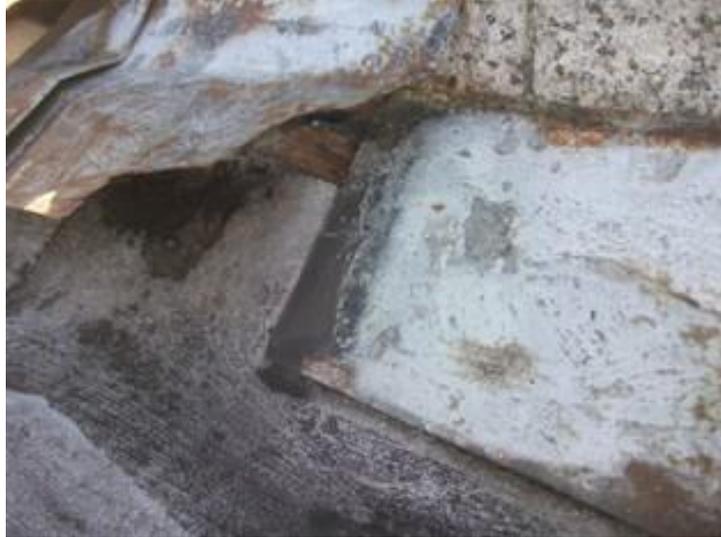
Repair: The counter flashing for the chimney has failed in many areas. This needs to be repaired by either a chimney mason or a qualified roofer. Currently with the damaged counter flashing, building framing and sheathing is exposed and is not protected by either roofing or flashing.

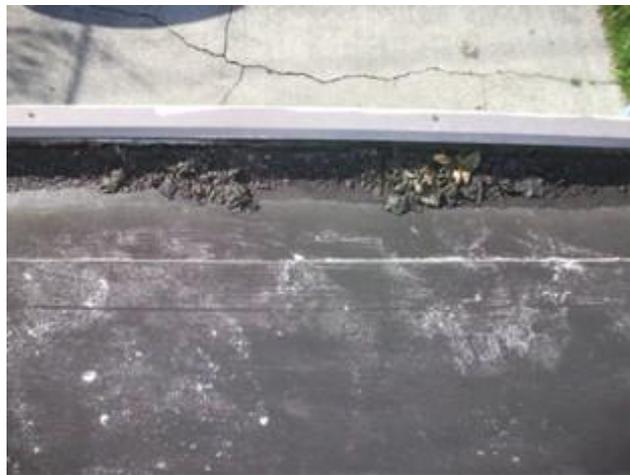
Maintain: Gutters are restricted in some areas around the roof. These need to be cleaned now and often to prevent pooling water on the roof and so water will adequately drain.

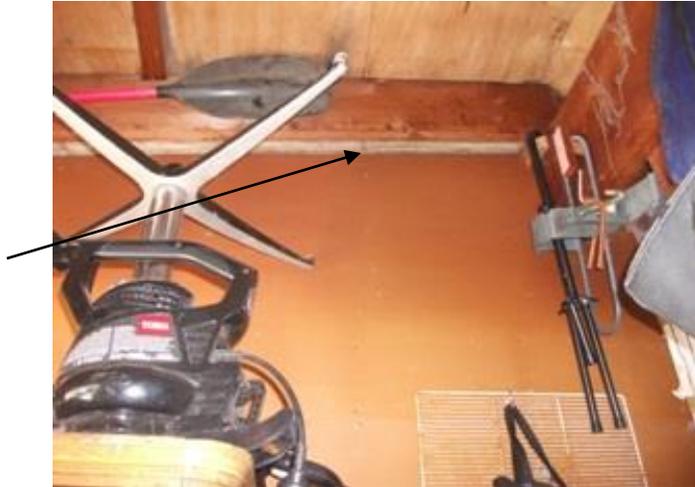
Safety: One or more wall surfaces between the attached garage and interior living spaces have gaps, holes, or missing or inadequate surface materials. These surfaces are intended to prevent vehicle fumes from entering living spaces, and to slow the spread of fire from the garage to living spaces. A qualified contractor should evaluate and make repairs as necessary so the attached garage wall and ceiling surfaces that adjoin living spaces are tightly sealed and fire rated as per standard building practices. Typically these surfaces require a one-hour fire rating.

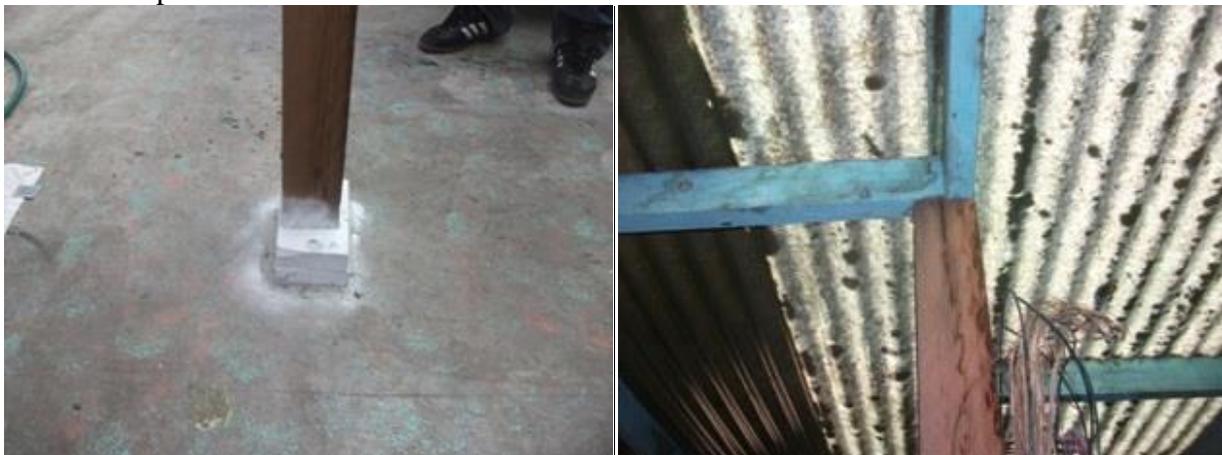
Repair: In the back garage addition, the roofing materials are not intended for permanent enclosures designed to last. The roofing materials will continue to fail exposing the back garage to conducive conditions. This room is an addition to the garage attached to the house and garage and should have a roof system with a better design. The rafters are over span and the posts are not adequately fastened to the beams or concrete. I recommend a qualified contractor evaluate and make repairs for the roof.

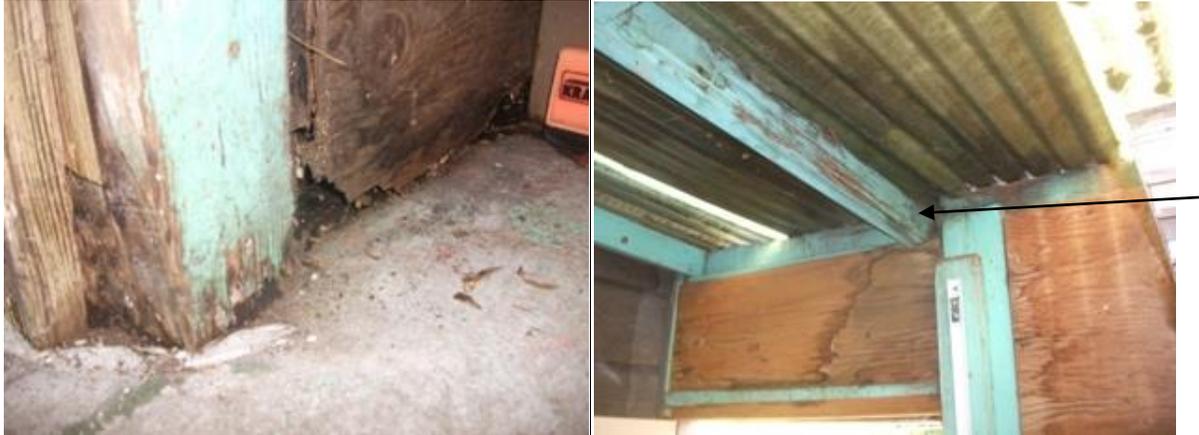
Repair/replace: The roof rafter as well as the framing/sheathing and door jamb on the north end of the garage has been damaged and infested by dampwood termites. This infestation was probably caused from the failed roof system above. Dampwood termites are typically a secondary infestation. Meaning if you remove the damp/decayed wood and eliminate the conducive/cultural condition the infestation should go away. All the damaged infested materials

need to be removed. The cause of moisture (most likely the roof) needs to be determined and eliminated. All the areas concealed behind stored items need to be revealed so if there are infestations and damage there they can be removed. Once all this is done the dampwood termite infestation should be eliminated with no treatment required. I recommend a one year follow up inspection focusing on this particular area to make any additional repairs or treatments.

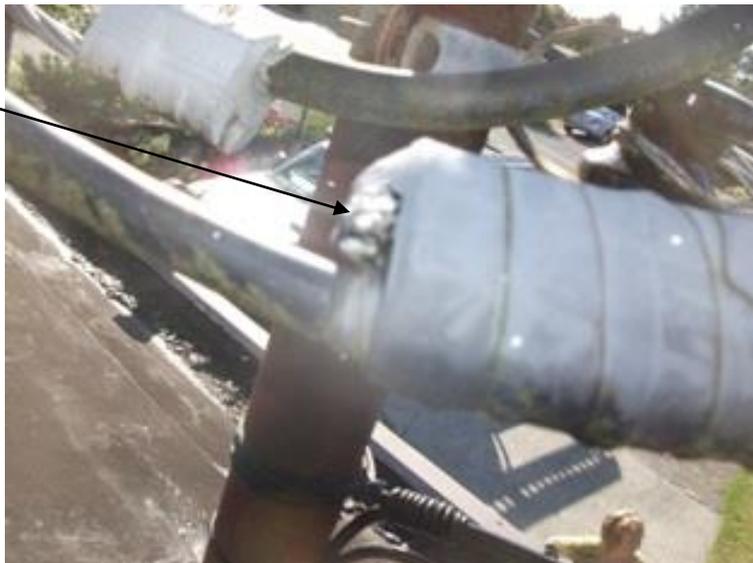
Safety: The service entrance conductor wires on the roof are exposed. The wires which are fastened together with electrical tape has some areas where bare wire is exposed. A qualified licensed electrician needs to evaluate this wire and tape the areas where the wire is exposed.

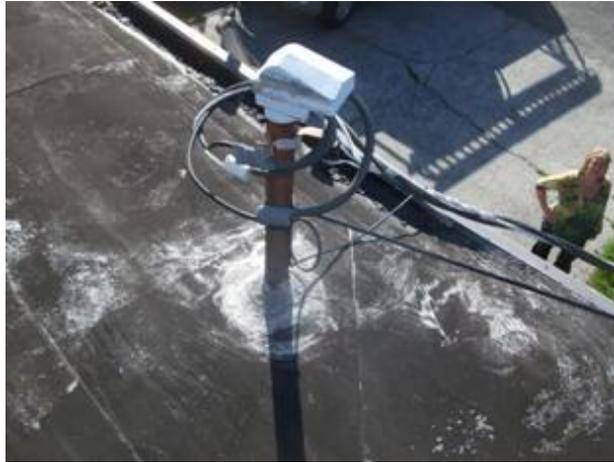
Repair: No drip loop is installed in the service entrance wires. Water may enter the service entrance conduit and equipment as a result. A qualified electrician should evaluate and repair as necessary.

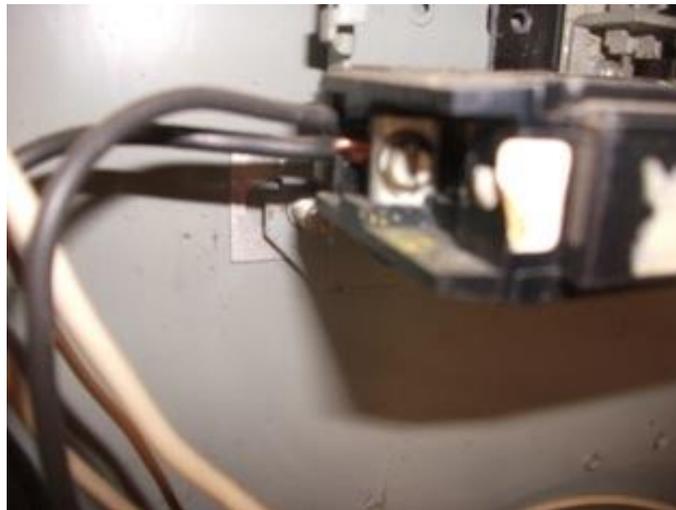
Repair: A breaker in the panel is "double tapped", where 2 or more wires are clamped in a terminal designed for only one wire. This is a safety hazard since the bolt or screw may tighten securely against one wire, but leave others loose. Arcing, sparks and fires may result. A qualified electrician should evaluate and repair as necessary.

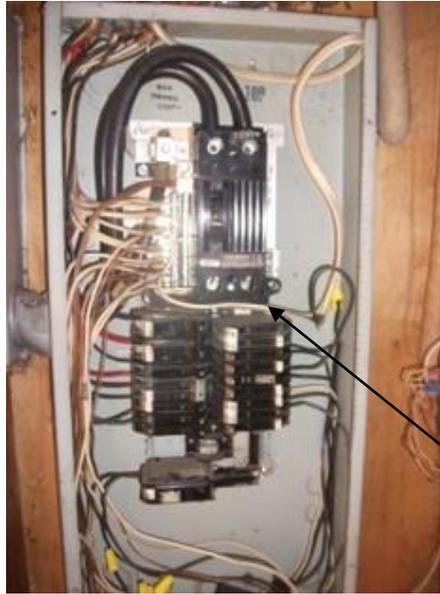
Repair: Wires in the panel are not supposed to run across the front of the panel. This wire should be moved so it goes to the breaker without crossing the face of the panel.

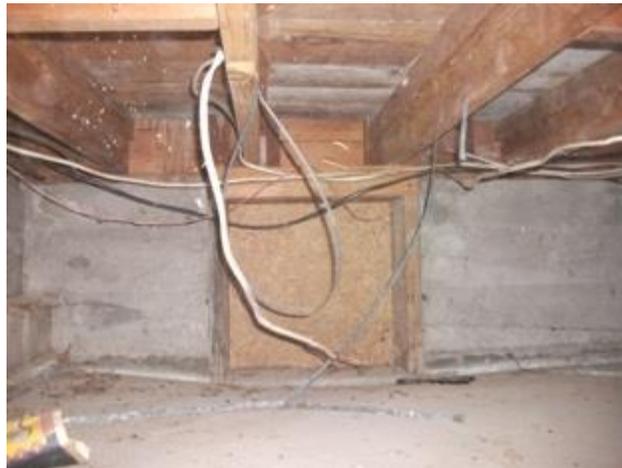
Safety: On the north and south side of the crawlspace wires are exposed and need to be contained in a covered junction box. This is a safety hazard due to the risk of shock and fire. A qualified electrician should evaluate and make repairs as necessary. For example, install securely mounted junction boxes with cover plates where needed to contain wiring.

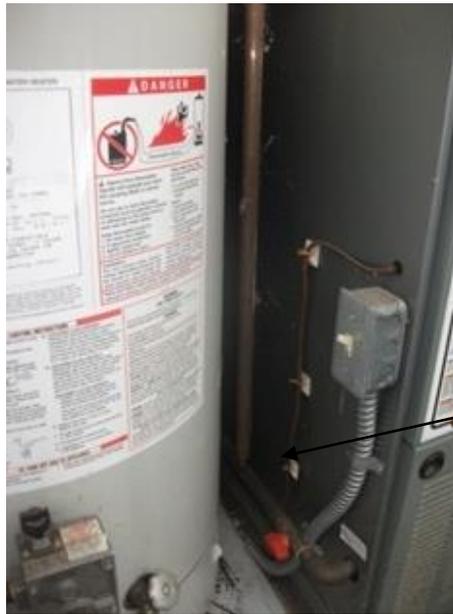
Replace/repair: The TPR valve on the top of the water tank is supposed to route down 6" from the ground. When the tank has a lot of pressure it releases water from this point. It needs to be routed towards the ground so no scalding water hits anyone. I recommend someone qualified re-route the TPR drain line 6" from the ground.

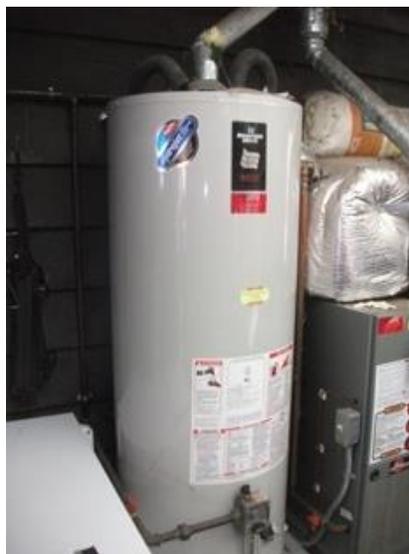
Repair: There are no seismic straps on the water heater. These are needed to keep the heater in place in a seismic event. One strap high and one strap low. I recommend someone qualified install seismic straps as required.

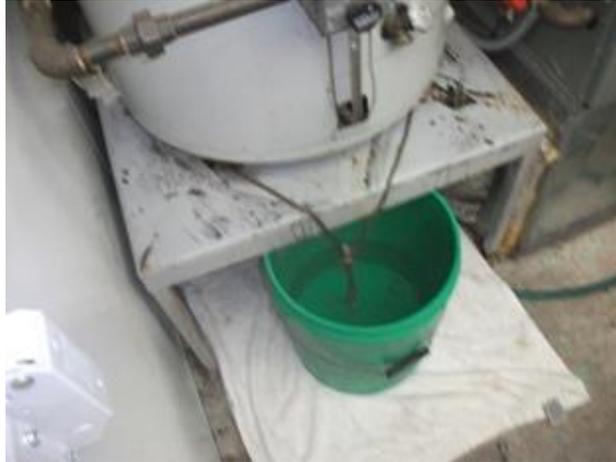
Replace: The hot water tank has failed and is leaking out of the bottom into a bucket. The hot water tank needs to be replaced by someone qualified to follow local safety codes and regulations. The above repairs are safety suggestions recommended if you were going to try and make the tank last a little longer.

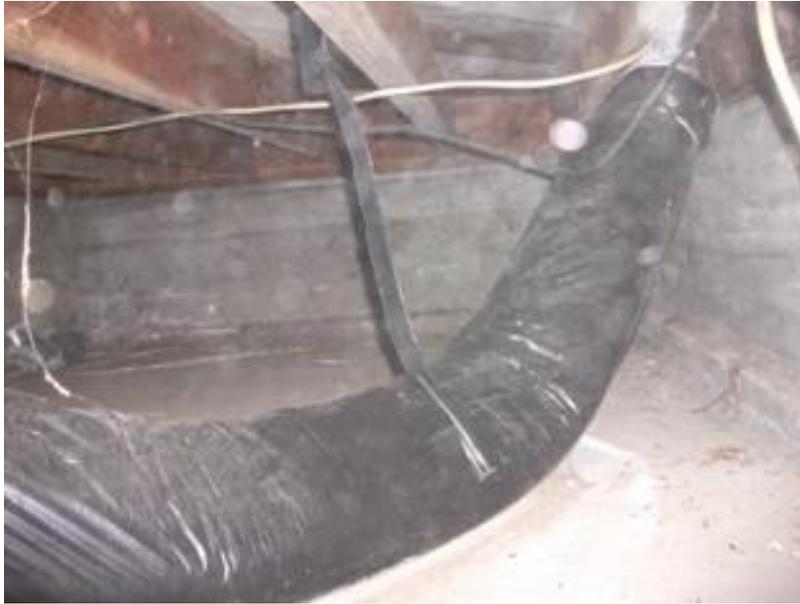
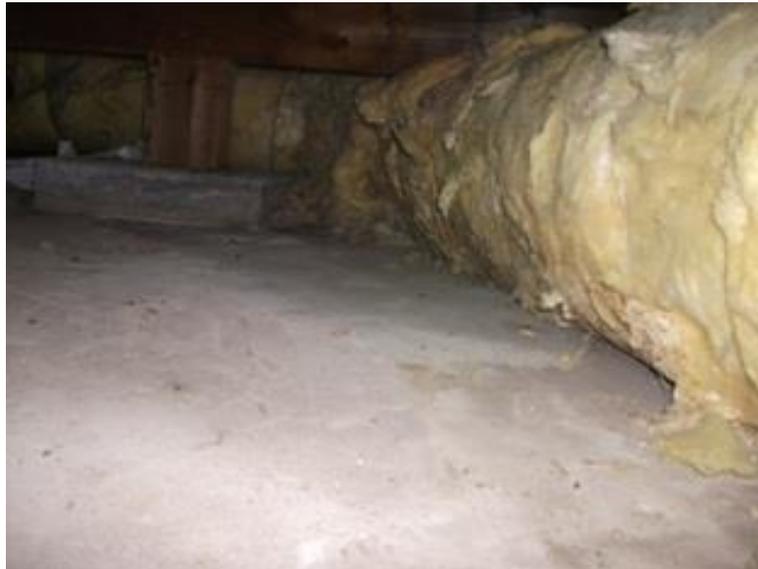
Repair: The heat registers that I could access provided adequate heat and maintained the specified temperature rise of 40-70 degrees. The heat register on the north side of the dining room provided no heat whatsoever. When I was in the crawlspace the ducting for this heat register was on the ground weighed down with water. The homeowner should be contacted about information regarding the flooding issue. Many other supply ducts throughout the crawlspace are contacting the ground which not only affects heat efficiency but may have water in them. A qualified heating technician needs to replace the obvious water soaked ducting and test the rest of the supply and return ducts for water and moisture and repair as needed. An air quality specialist should also be contacted to determine if there is moisture in other ducts. For more information on duct cleaning in relation to indoor air quality, visit:

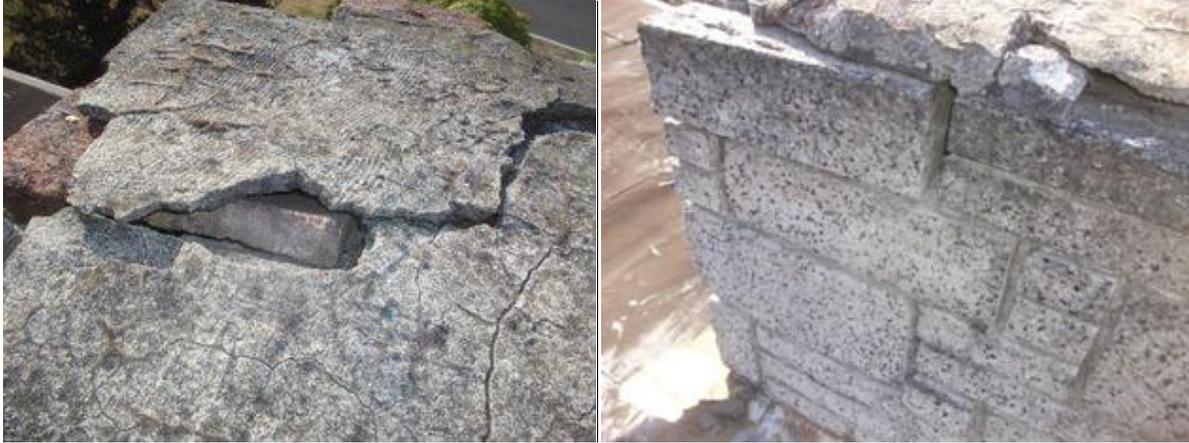
Repair: The chimney viewed from the roof needs repair in many areas. The chimney cap is damaged and needs to be repaired. Many bricks are loose and either need to be repaired or re-set. Many joints are missing mortar and need to be re-struck. All these deficiencies create a conducive condition because water can enter into living space through the faulty brick. I was unable to view the attic to see if there was any water damage on the common wall. I recommend a qualified mason evaluate and make repairs as necessary.

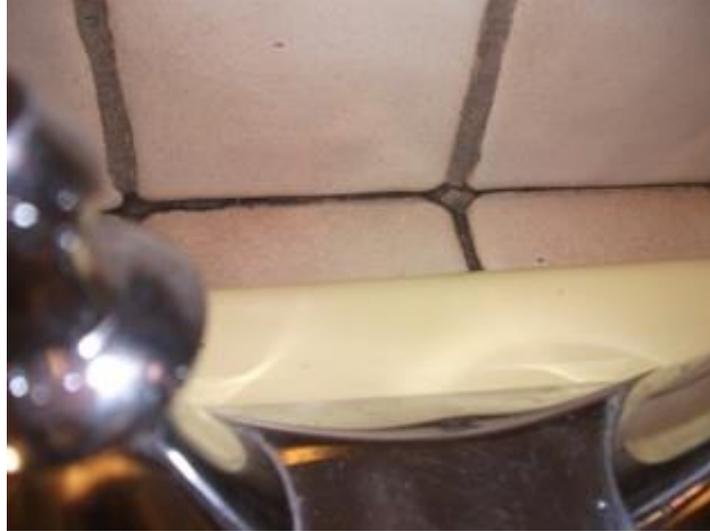
Repair: The backsplash behind the kitchen sink needs silicone where it meets the counter top. This is to prevent water damage if water were to get behind the sink which is common.

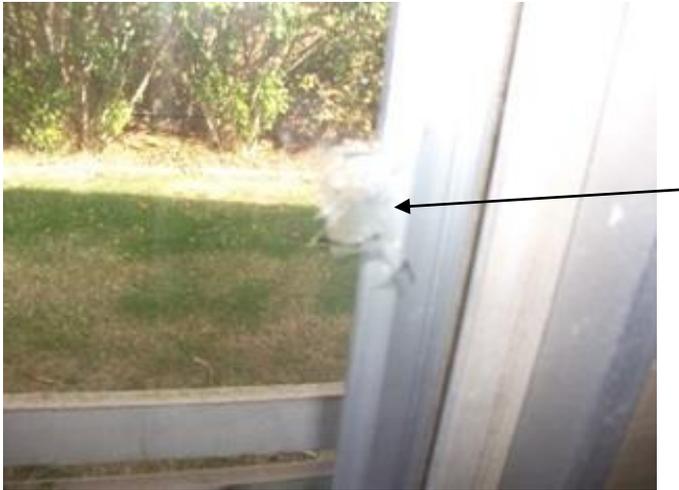
Comment/repair: Many windows appear to be the original single pane windows. For better efficiency you may want to replace these windows. The dining window has a small crack in it. Some of the bedroom doors stick when they are shut. The exterior doors are not solid core. Solid core doors are recommended on exterior application for not only energy reasons but for security.

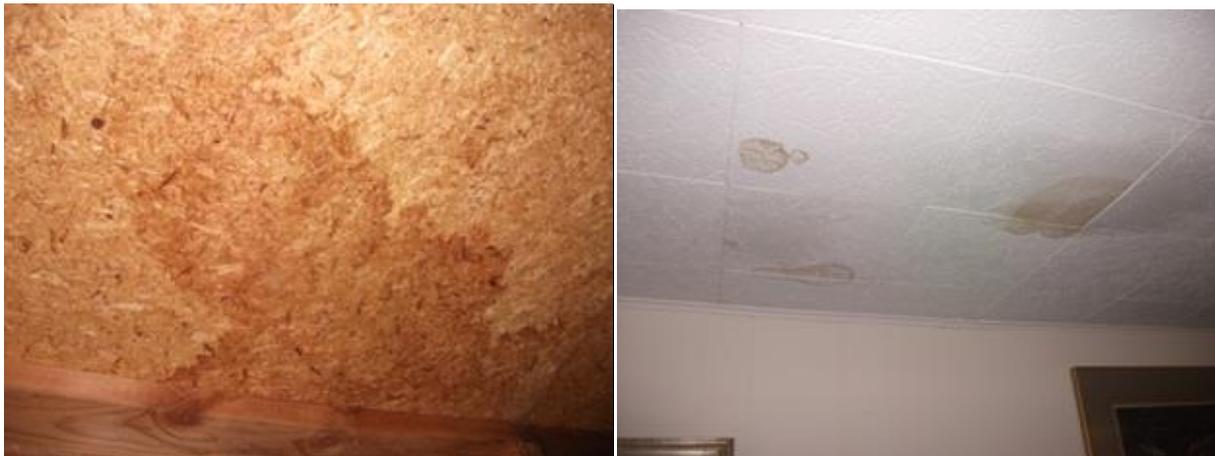
Evaluate: In the basement there are water stains on the ceiling. The areas with noticeable staining are at the bottom of the stairs along the south wall. Above this staining is the front door where there was wood rot, carpenter ant evidence, and a defective porch (see exterior). The other area of concern is in the ceiling in the storage room under the stairs. This is a concern because the kitchen is directly above. The water soaked heat ducting in the crawlspace indicates there has been a large leak in the kitchen. When water leaks through the ceiling and has no ventilation or way to dry, microbial/mildew will rapidly grow and can severely affect air quality. I recommend consulting the homeowner about the leak and if there were any treatments. I also recommend having the ceiling covering removed in these areas and inspected by someone qualified for water damage and microbial growth. If there is **any** evidence of microbial growth and moisture a specialist needs to evaluate this area and make all repairs as necessary.

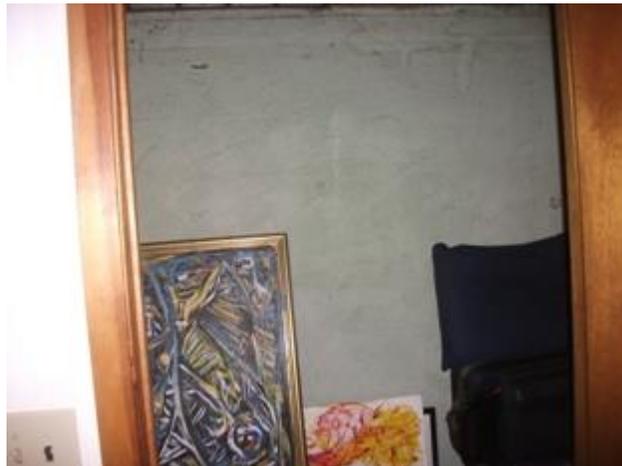
Repair: Based on the age of the house, there may not be any insulation in the attic. This is another reason why there should be an access. Insulation should be blown into the attic by a qualified company for better energy efficiency. I was unable to determine any exterior wall insulation. When a qualified insulation contractor is on site you may want to have him evaluate the walls and install additional insulation. In the basement, the storage room under the stairs should have insulation installed along the concrete wall as well.

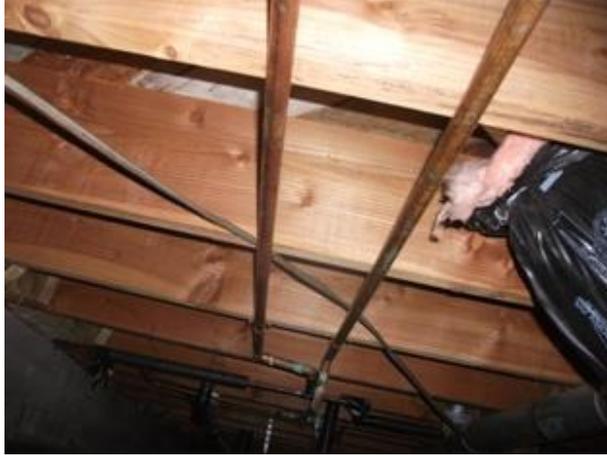
Repair: No insulation is installed under the floor in the crawl space. Recommend that a qualified contractor install R19 or better (6" thick fiberglass batt) insulation under the floor for better energy efficiency. All of the water lines need to be insulated as well to prevent bursting when it freezes.

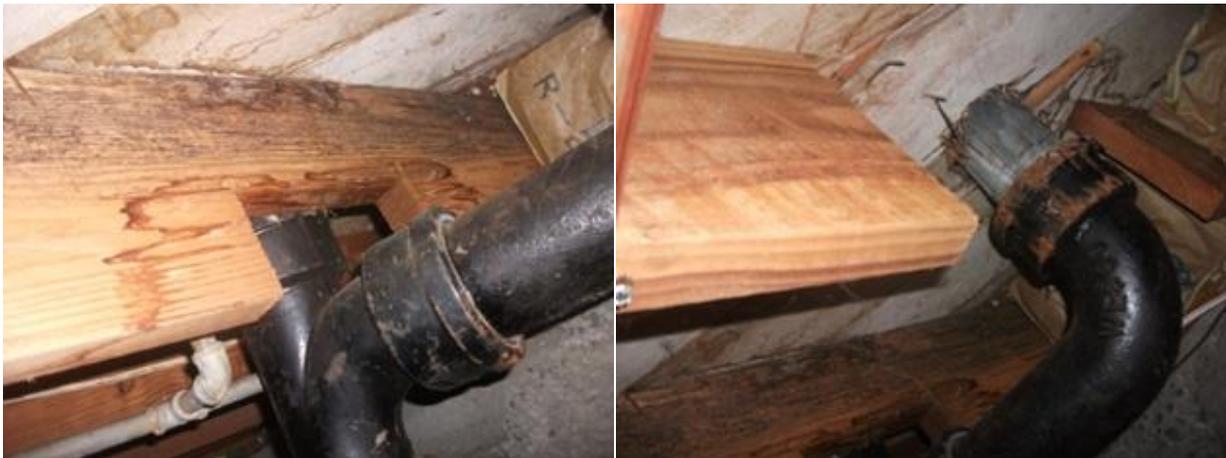
Repair: One or more joists are damaged due to non-standard or substandard notching and/or hole boring. Standard building practices specify the following limitations for notching and boring joists:

The floor joists to the south of the crawl access, below the hall bathroom have been notched and cut for the plumbing. This is a structural concern because two joists next to each other have both been cut so there is no positive joist support for nearly 48". A structural engineer or a qualified contractor should evaluate and repair as necessary.

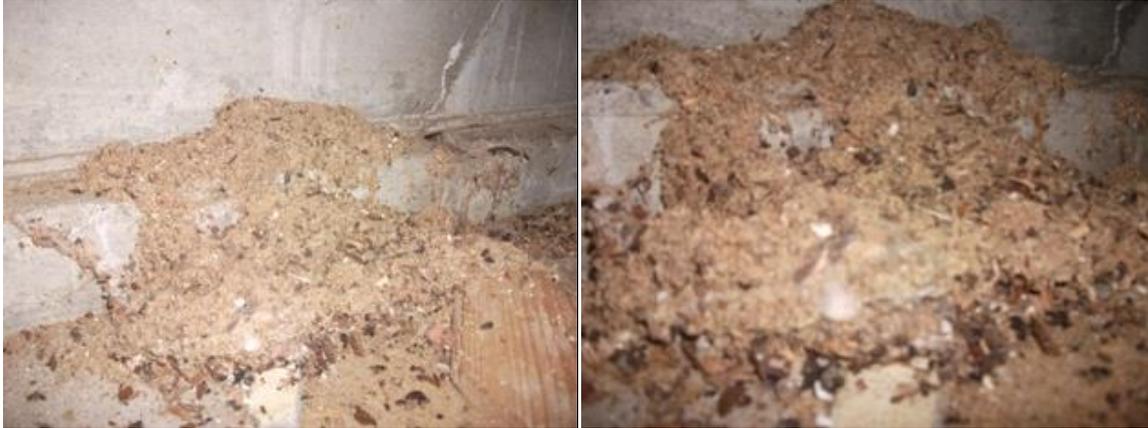
Evaluate: Carpenter ant frass is evident in the south end of the crawlspace. The amount of frass identified indicates a significant amount of activity. Directly above this location is the area on the front of the house where soil is against the house contacting the metal skirt board. I was unable to inspect the siding in this area because of the skirting and soil. While I was in the crawlspace I did not see any live carpenter ants at the time of the inspection. That does not mean they are not active. Again, consult the property owner, this may have been recently treated and the pest control specialist simply did not clean up the carpenter ant frass. In my exterior inspection I did see a carpenter ant near this location in the siding. If it has been previously treated there may be a warranty. Regardless, a pest control specialist needs to evaluate these areas and treat as necessary.
