TO THE T HOME INSPECTIONS LLC

Property Inspection Report# XXXXXX
Client: XXXXXX
Property Address: XXXXXXXX ST SW Edmonds WA 98026
Inspection Date: 9/30/11
WSDA ICN # 1239AQ014

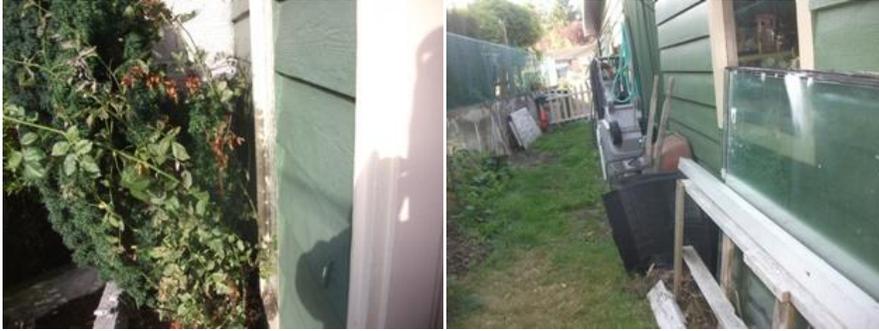
- Many sections of foundation and/or exterior walls are excluded from this inspection due to lack of access from vegetation, debris and/or stored items. When vegetation is in direct contact with the exterior building materials it causes a lot of moisture exposure to those areas that are not suitable for those conditions. Also, this is a good path for wood destroying insects to find their way into the building. Recommend trimming the vegetation back 6"-12".

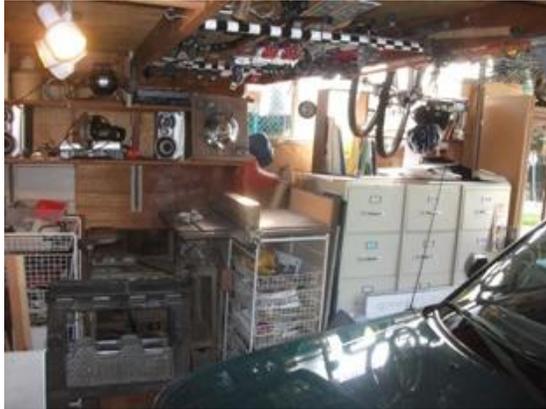
- Much of the garage, including areas around the interior perimeter and in the center are excluded from this inspection due to lack of access from stored items.

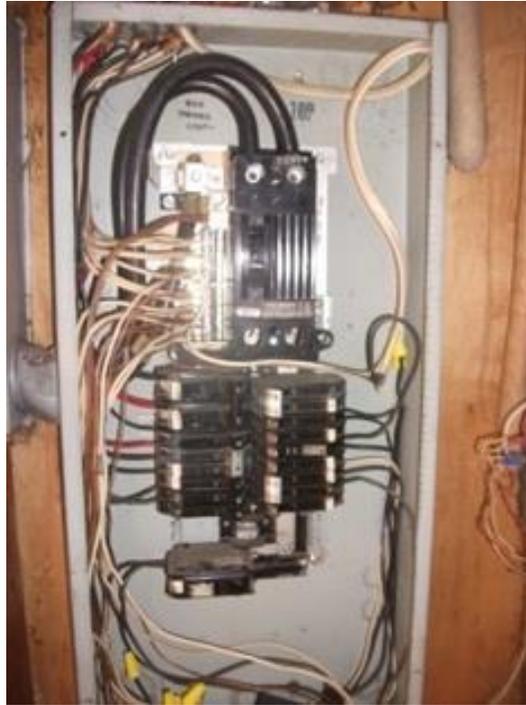
Excluded: Electrical panels are crowded with wires. To avoid disruption of wires I do not move wires around. Therefore many areas of the panel could not be fully evaluated.

Repair: Wires in the panel are not supposed to run across the front of the panel. This wire should be moved so it goes to the breaker without crossing the face of the panel.

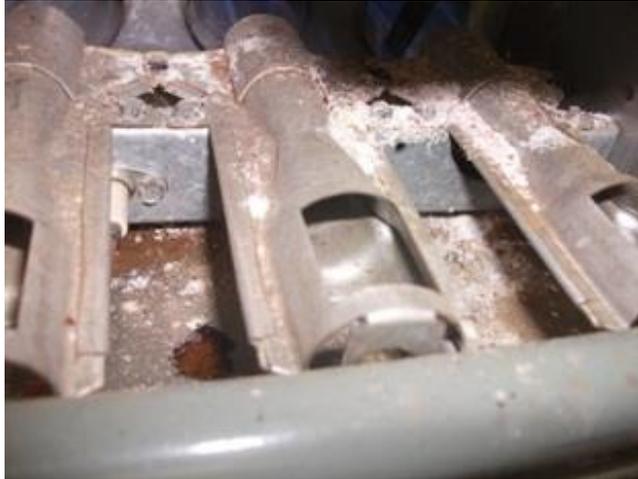
Repair: The heat registers that I could access provided adequate heat and maintained the specified temperature rise of 40-70 degrees. The heat register on the north side of the dining room provided no heat whatsoever. When I was in the crawlspace the ducting for this heat register was on the ground weighed down with water. The homeowner should be contacted about information regarding the flooding issue. Many other supply ducts throughout the crawlspace are contacting the ground which not only affects heat efficiency but may have water in them. A qualified heating technician needs to replace the obvious water soaked ducting and test the rest of the supply and return ducts for water and moisture and repair as needed. An air quality specialist should also be contacted to determine if there is moisture in other ducts. For more information on duct cleaning in relation to indoor air quality, visit:

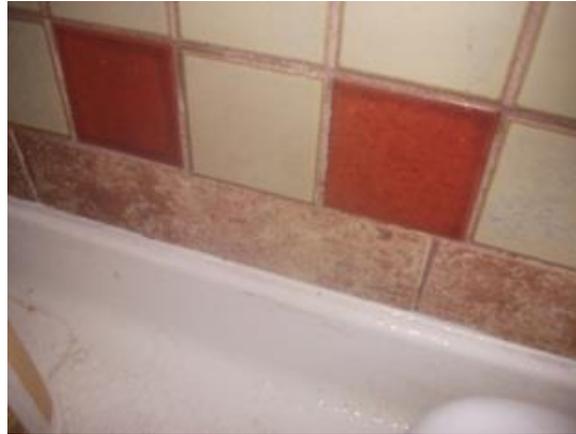
Comment/repair: The master bathroom shower appears to have had repairs done. The tiles on the bottom row are different indicating they have been replaced. My concern with this is that usually when the bottom row of tiles are replaced the backer board and framing often are damaged as well. In this situation the above tiles have not been replaced so the backer board could not have been replaced. When I pressed on the tiles they felt stiff at the time of the inspection. When there is damage behind the tiles usually the wall will slightly flex. There is no way for me to determine

exactly what happened in this shower. When I was in the crawlspace I viewed the area below the best I could based on my mobility and did not see any signs of active leaking. I recommend consulting with the home owner for more information about this.

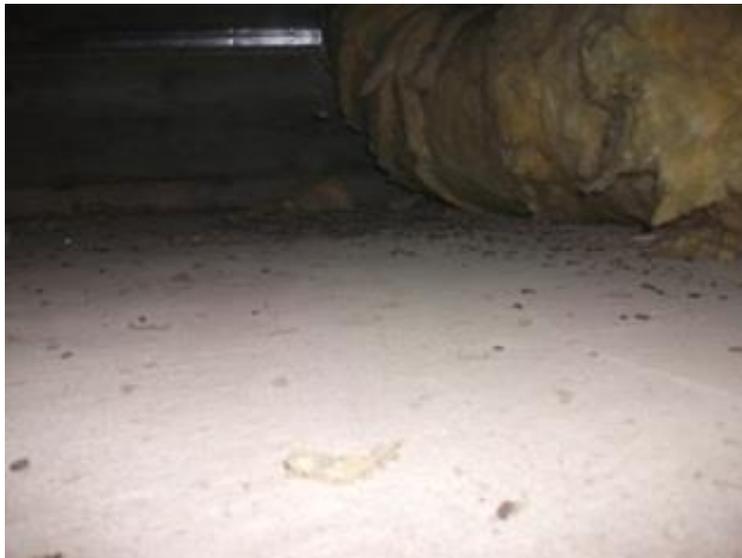
Evaluate: Evidence of "heavy" rodent infestation was found in the crawlspace. The Center for Disease Control (CDC) defines this as more than 20 feces per square foot. Rodent infestation may be a safety hazard due to the risk of contracting [\[url="http://www.cdc.gov/ncidod/diseases/hanta/hps/noframes/FAQ.htm"\]](http://www.cdc.gov/ncidod/diseases/hanta/hps/noframes/FAQ.htm) Hantavirus Pulmonary Syndrome (HPS)[/url]. HPS is a rare (only 20-50 cases per year in the United states) but deadly (40% mortality rate) disease transmitted by infected rodents through urine, droppings, or saliva. Humans can contract the disease when they breathe in aerosolized virus. For example, from sweeping up rodent droppings.

Because this infestation is "heavy", recommend that the clients consult with a qualified pest control operator for extermination services. Also recommend consulting with a qualified, licensed abatement contractor or industrial hygienist for clean up of rodent waste and nesting materials. For more information on eradication, clean up and prevention of rodent infestations, read the CDC's [\[url="http://www.cdc.gov/ncidod/diseases/hanta/hps_stc/stc_spot.htm"\]](http://www.cdc.gov/ncidod/diseases/hanta/hps_stc/stc_spot.htm)Clean Up, Trap Up, Seal Up[/url] article.
